Subject: Wetland and Stream Delineation Report
NorthPoint Development
Maryland Heights, St. Louis County, Missouri
CEC Project 324-613

Civil & Environmental Consultants, Inc. (CEC) is pleased to submit this Wetland and Stream Delineation Report for a proposed development located in Maryland Heights, St. Louis County, Missouri (38.733591, -90.506924). This report details the technical criteria, field indicators, and other sources of information used to delineate wetlands, streams, and other waterbodies on the referenced property. Based on the findings of the delineation, nine (9) wetlands were identified and delineated within the limits of the survey area. It is CEC's opinion that none of these wetlands (WTL-1 through WTL-9) would likely be subject to U.S. Army Corps of Engineers jurisdiction and would be excluded from Clean Water Act Section 404 permitting requirements.

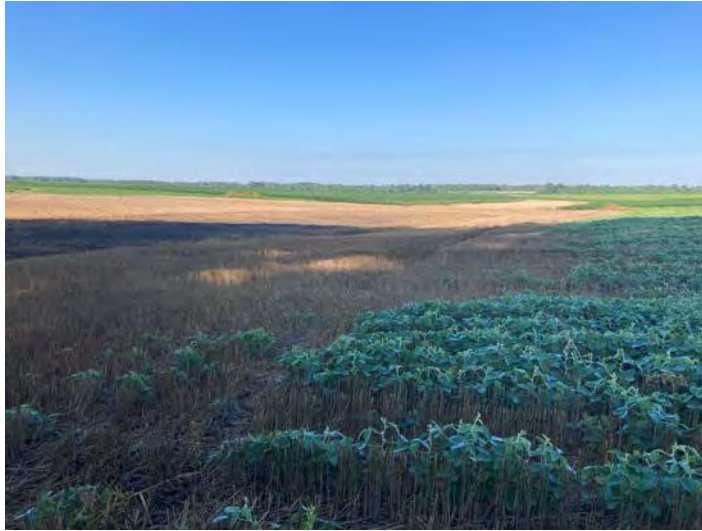
Photo Number: 1

Description: Emergent wetland (WTL-1). Direction of view (DOV) is southwest.

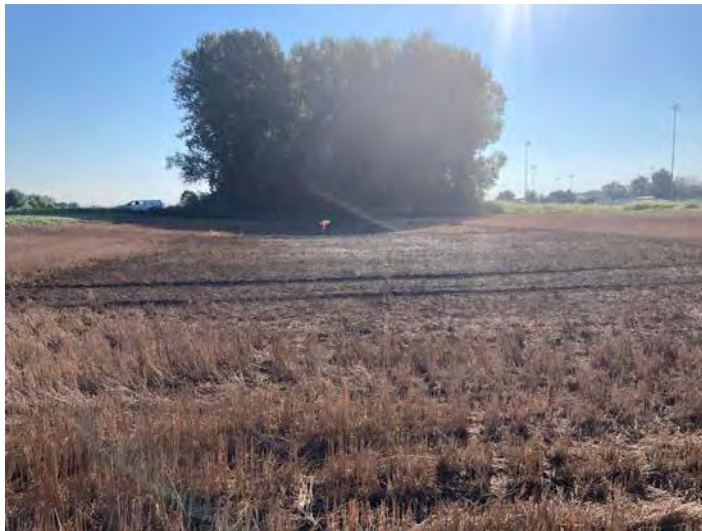
Photo Number: 2

Description: WTL-1. DOV is northeast.

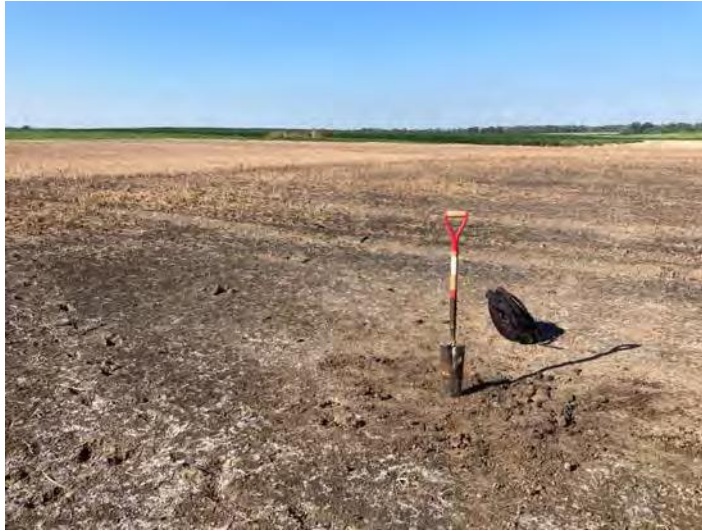
Photo Number: 3

Description: WTL-1. Photo taken of sample point (SP-1). DOV is southwest.

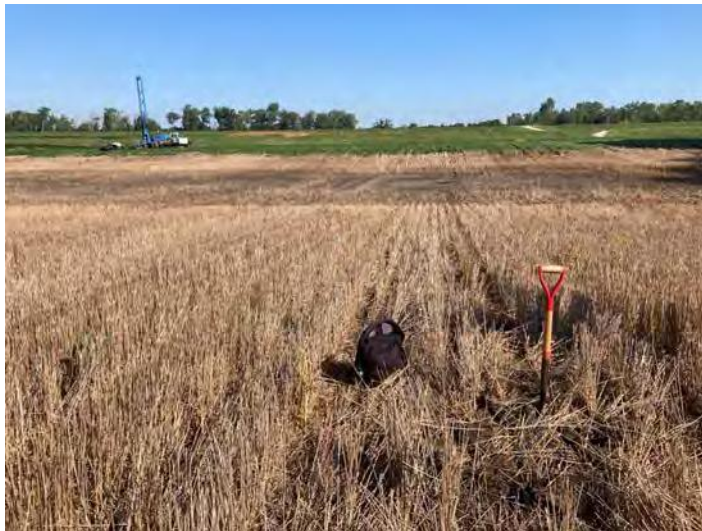
Photo Number: 4

Description: WTL-1. Photo taken of SP-2. DOV is northwest.

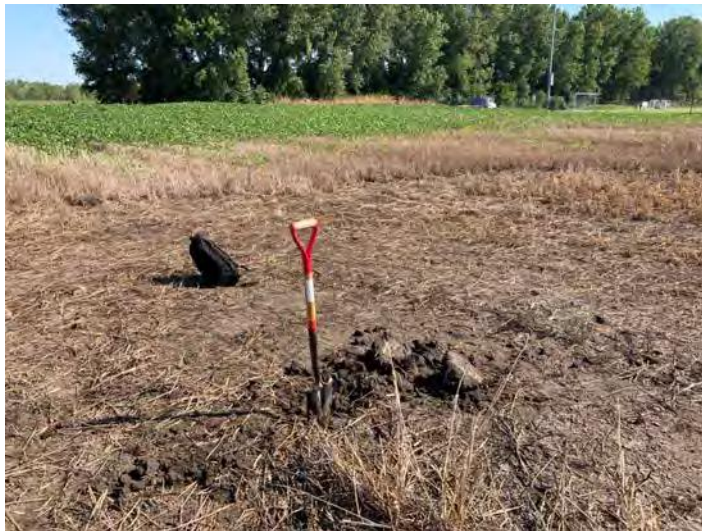
Photo Number: 6

Description: Emergent wetland (WTL-2). Photo taken of SP-4. DOV is northeast.

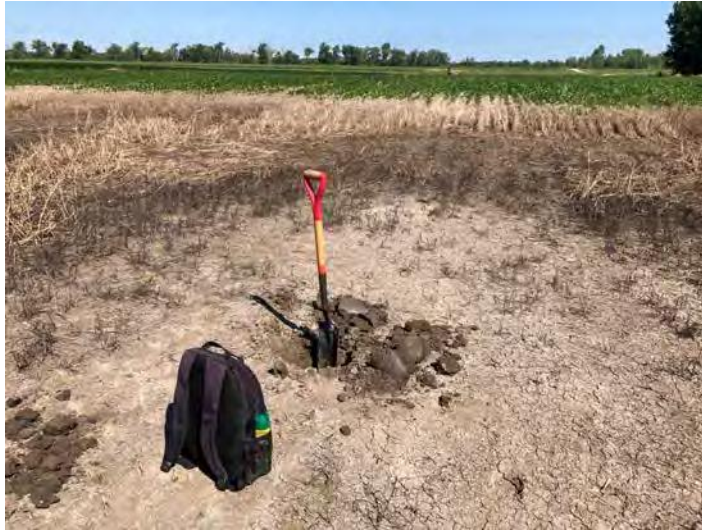
Photo Number: 9

Description: WTL-3. Photo taken of SP-5. DOV is northwest.

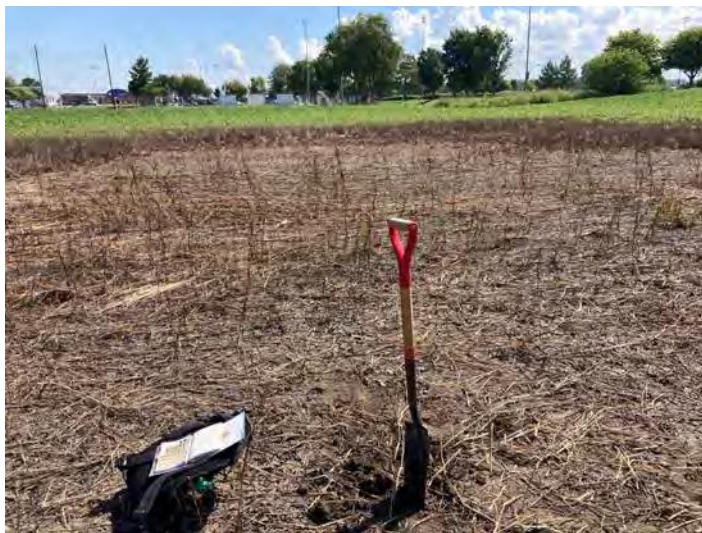
Photo Number: 14
Description: Emergent wetland (WTL-4). Photo taken of SP-7. DOV is east.

data form (SP-7; Appendix A), the observed vegetation included prostrate pigweed (*Amaranthus albus*) and yellow nutsedge (*Cyperus esculentus*) but the vegetation was largely problematic as the area did not include a natural plant community. According to the Munsell™ color chart, SP-7 soils were 10YR 3/2 from the soil surface to a depth of 16 inches with redoximorphic features (10YR 3/6 and 10YR 5/1). The soil at this sample point was considered problematic hydric soils due to seasonal ponding and disturbances to the soil profile from farming practices. The soils were borderline on meeting the hydric soil indicator for redox dark surface (F6). Wetland hydrology indicators for SP-7 included algal mat or crust (B4) and saturation visible on aerial imagery (C9). This area was delineated as wetland due to the presence of both primary and secondary wetland hydrology indicators. WTL-4 is an isolated wetland that appears to be confined to the agricultural field. WTL-4 does not appear to have a direct or indirect surface connection to a TNW and does not appear to have any significant relationship to the physical, chemical, or biological integrity of a TNW. Therefore, WTL-4 has minimal function or value as a wetland. Since WTL-4 lacks a significant nexus to a TNW via other waters of the United States, it is CEC's professional opinion that WTL-4 is likely not subject to USACE jurisdiction.

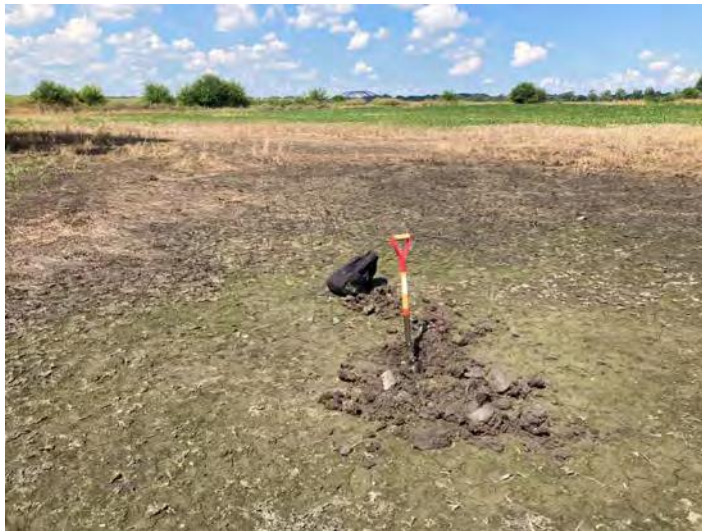
Photo Number: 16
Description: Emergent wetland (WTL-5). Photo taken of SP-8. DOV is west.

Wetland 5 (WTL-5) is a 0.08-acre PEM/0.02-acre PSS wetland located in a depression in the southeastern portion of the survey area (Figure 5). As indicated on the wetland determination data form SP-8 (Appendix A), the vegetation was problematic within the PEM portion as the area did not contain a natural plant community due to active farming practices. For SP-10 (Appendix A), PSS portion of WTL-5, the observed vegetation met the dominance test as hydrophytic vegetation indicator. The dominant vegetation observed was white mulberry (*Morus alba*) in the tree stratum; black willow (*salix nigra*) in the sapling/shrub stratum; curly dock (*Rumex crispus*), tapered rosette grass (*Dichanthelium acuminatum*), Pennsylvania smartweed (*Polygonum pennsylvanicum*), eastern woodland sedge (*Carex blanda*), green bristlegrass (*Setaria viridis*), and johnsongrass (*Sorghum halepense*) in the herbaceous stratum; and riverbank grape (*Vitis riparia*) in the woody vine stratum. According to the Munsell™ color chart, SP-8 soils were 10YR 3/1 from the soil surface to a depth of 16 inches with redoximorphic features (10YR 3/6 and 10YR 5/1). SP-10 soils were 10YR 3/2 with redoximorphic features (10YR 5/1). The soils at these sample points were considered problematic hydric soils due to seasonal ponding and disturbances to the soil

profile from farming practices. The soils were borderline on meeting the hydric soil indicator for redox dark surface (F6). Wetland hydrology indicators for SP-8 included algal mat or crust (B4), sparsely vegetated concave surface (B8), surface soil cracks (B6), drainage patterns (B10), and saturation visible on aerial imagery (C9); while SP-10 included drift deposits (B3), drainage patterns (B10), and FAC-neutral test. This area was delineated as wetland due to the presence of both primary and secondary wetland hydrology indicators, and the presence of hydrophytic vegetation. WTL-5 is an isolated wetland that appears to be confined to the agricultural field but does have connectivity to a constructed ditch (D-1) and WTL-6 just outside of the survey area. WTL-5 does not appear to have a direct or indirect surface connection to a TNW and does not appear to have any significant relationship to the physical, chemical, or biological integrity of a TNW. Therefore, WTL-5 has minimal function or value as a wetland. Since WTL-5 lacks a significant nexus to a TNW via other waters of the United States, it is CEC's professional opinion that WTL-5 is likely not subject to USACE jurisdiction.

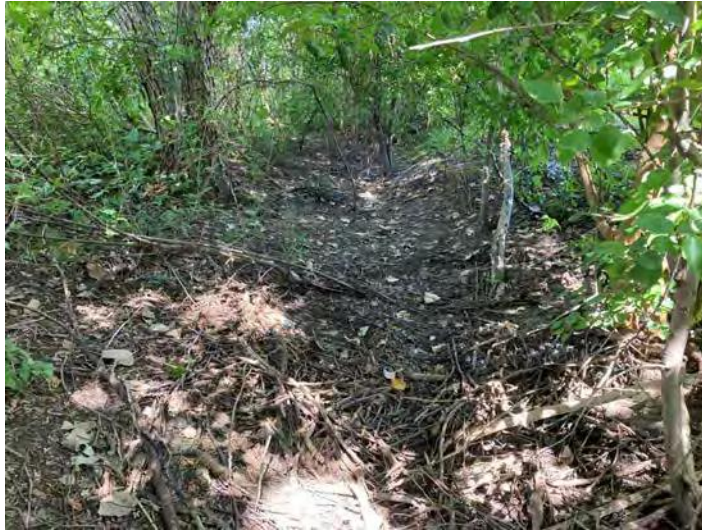
Photo Number: 19

One (1) constructed ditch (D-1) was observed during the field reconnaissance running along the southeast boundary of the survey area. This feature did not have defined bed and banks and did not appear to have groundwater input. This feature appears to only convey surface water run-off in direct response to precipitation events. Therefore, in CEC's professional opinion, this feature would not be subject to USACE jurisdiction.

Description: Ditch (D-1). DOV is northwest.

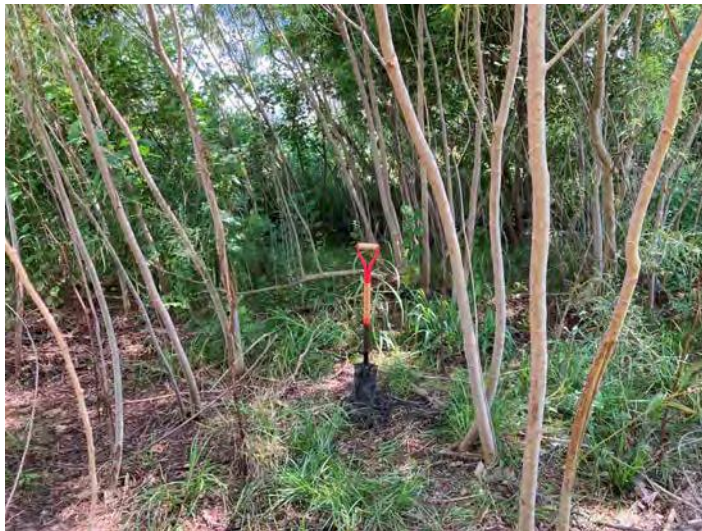
Photo Number: 20

Description: Scrub/shrub wetland (WTL-5). Photo taken of SP-10. DOV is northeast.

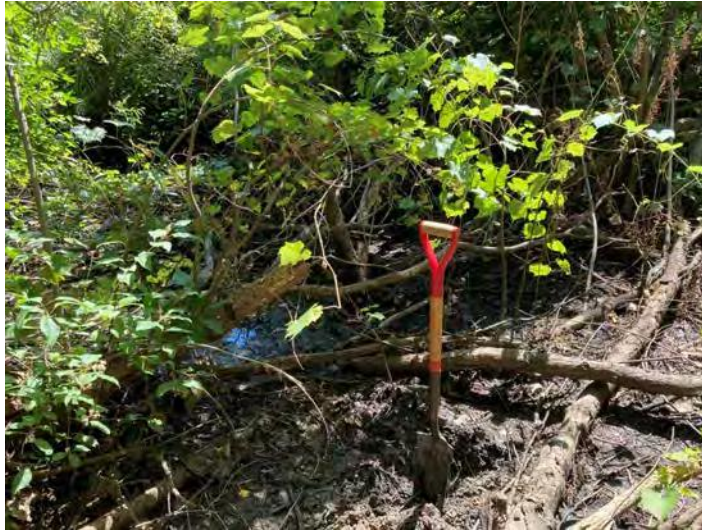
Photo Number: 21

Wetland 6 (WTL-6) is a 0.11-acre PFO wetland located in a depression surrounded by trees just outside the boundary of the southeastern portion of the survey area (Figure 5). As indicated on the wetland determination data form (SP-9, Appendix A), the observed vegetation for SP-9 met the dominance test as hydrophytic vegetation indicator. The dominant vegetation observed was eastern cottonwood (*Populus deltoides*), black willow, and river birch (*Betula nigra*) in the tree stratum; black willow, white mulberry, and roughleaf dogwood (*Cornus drummondii*) in the sapling/shrub stratum; and riverbank grape in the woody vine stratum. According to the Munsell™ color chart, SP-9 soils were 10YR 4/1 from the soil surface to a depth of 16 inches with redoximorphic features (10YR 3/6), meeting the hydric soil indicator for depleted matrix (F3). Wetland hydrology indicators for SP-9 included high water table (A2), saturation (A3), drift deposits (B3), aquatic fauna (B13), drainage patterns (B10), geomorphic position (D2), and FAC-neutral test (D5). It should be noted that the high water table and saturation hydrology indicators for this wetland may be due to the wetter than normal conditions at the time of the field visit. WTL-6 is an isolated wetland that has a direct connection to a constructed ditch (D-1). WTL-6 does not appear to have a direct or indirect surface connection to a TNW and does not appear to have any significant relationship to the physical, chemical, or biological integrity of a TNW.

Description: Forested wetland (WTL-6). Photo taken of SP-9. DOV is southwest.

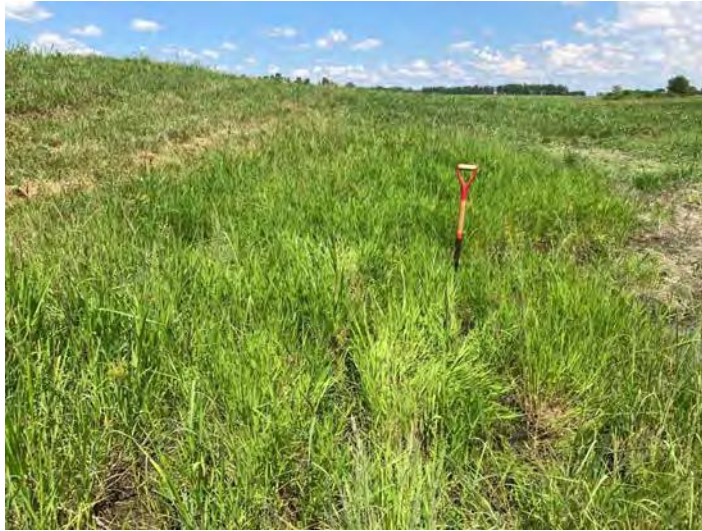
Photo Number: 33

Wetland 7 (WTL-7) is a 0.02-acre PEM wetland located at the toe of a slope between a levee and an agricultural field along and just outside the northeastern portion of the survey area (Figure 5). As indicated on the wetland determination data form (SP-12, Appendix A), the observed vegetation met the dominance test as hydrophytic vegetation indicator. The dominant vegetation observed was rice cutgrass (*Leersia oryzoides*) in the herbaceous stratum. According to the Munsell™ color chart, SP-12 soils were 10YR 3/1 from the soil surface to a depth of 16 inches with redoximorphic features (10YR 3/6 and 10YR 5/1), meeting the hydric soil indicator for redox dark surface (F6). Wetland hydrology indicators for SP-12 included surface water (A1), high water table (A2), saturation (A3), hydrogen sulfide odor (C1), geomorphic position (D2), and FAC-neutral test (D5). It should be noted that the surface water, high water table, and saturation hydrology indicators for this wetland may be due to the wetter than normal conditions at the time of the field visit. WTL-7 is an isolated wetland that does not appear to have a direct or indirect surface connection to a TNW and does not appear to have any significant relationship to the physical, chemical, or biological integrity of a TNW. Therefore, WTL-7 has minimal function or value as a wetland. Since WTL-7 lacks a significant nexus to a TNW via other waters of the United States, it is CEC's professional opinion that WTL-7 is likely not subject to USACE jurisdiction.

Description: Emergent wetland (WTL-7). Photo taken of SP-12. DOV is northwest.

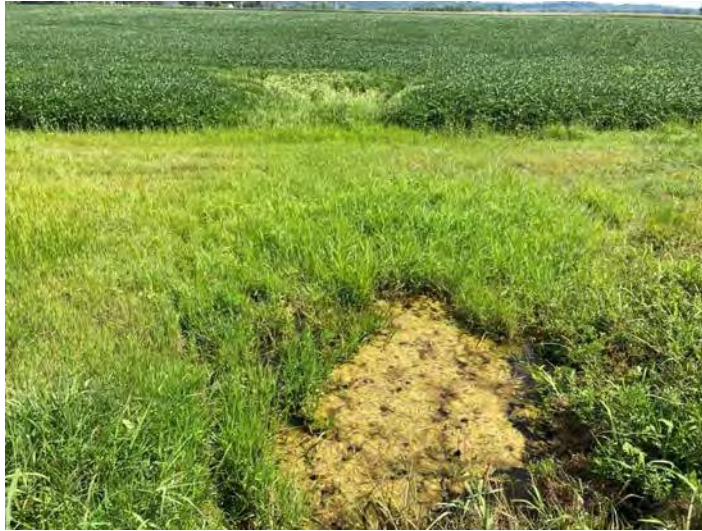
Photo Number: 39

Wetland 8 (WTL-8) is a 0.06-acre PEM wetland located at the toe of a slope between a levee and an agricultural field in and just outside the northwestern portion of the survey area (Figure 5). As indicated on the wetland determination data form (SP-14, Appendix A), the observed vegetation met the dominance test as hydrophytic vegetation indicator. The dominant vegetation observed was rice cutgrass and calamus (*Acorus calamus*) in the herbaceous stratum. According to the Munsell™ color chart, SP-14 soils were 2.5Y 3/1 from the soil surface to a depth of 16 inches with redoximorphic features (10YR 3/6), meeting the hydric soil indicator for sandy redox (S5). The soil also had a hydrogen sulfide smell meeting the hydric soil indicator for hydrogen sulfide (A4).

Description: Emergent wetland (WTL-8). DOV is southeast.

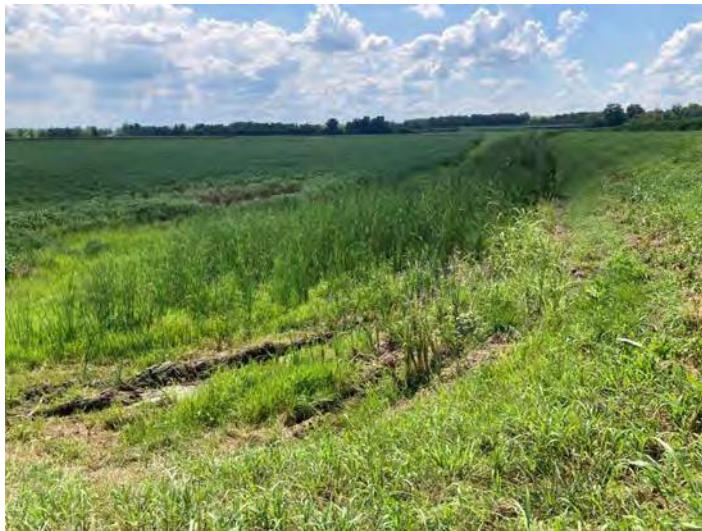
Photo Number: 40

Wetland 9 (WTL-9) is a 0.25-acre PEM wetland located at the toe of a slope between a levee and an agricultural field in the northwestern portion of the survey area (Figure 5). As indicated on the wetland determination data form (SP-16, Appendix A), the observed vegetation met the dominance test as hydrophytic vegetation indicator. The dominant vegetation observed was broadleaf cattail (*typha latifolia*) and softstem bulrush (*Schoenoplectus tabernaemontani*) in the herbaceous stratum. According to the Munsell™ color chart, SP-16 soils were 2.5Y 3/1 from the soil surface to a depth of 16 inches with redoximorphic features (10YR 3/6), meeting the hydric soil indicator for sandy redox (S5). The soil also had a hydrogen sulfide smell meeting the hydric soil indicator for hydrogen sulfide (A4). Wetland hydrology indicators for SP-16 included surface water (A1), high water table (A2), saturation (A3), algal mat or crust (B4), hydrogen sulfide odor (C1), stunted or stressed vegetation (D1), geomorphic position (D2), and FAC-neutral test (D5). It should be noted that the surface water, high water table, and saturation hydrology indicators for this wetland may be due to the wetter than normal conditions at the time of the field visit. WTL-9 is an isolated wetland that does not appear to have a direct or indirect surface connection to a TNW and does not appear to have any significant relationship to the physical, chemical, or biological integrity of a TNW. Therefore, WTL-9 has minimal function or value as a wetland. Since WTL- 9 lacks a significant nexus to a TNW via other waters of the United States, it is CEC's professional opinion that WTL-9 is likely not subject to USACE jurisdiction.

Description: Emergent wetland (WTL-9). DOV is southwest.

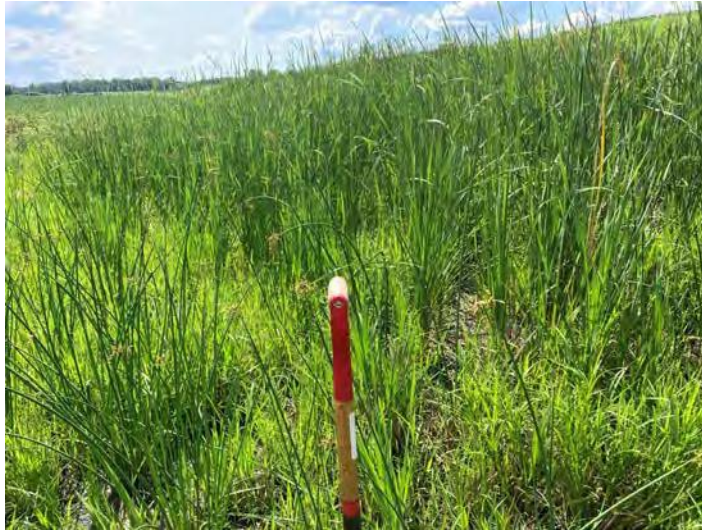
Photo Number: 43

Description: WTL-9. Photo taken of SP-16. DOV is west.

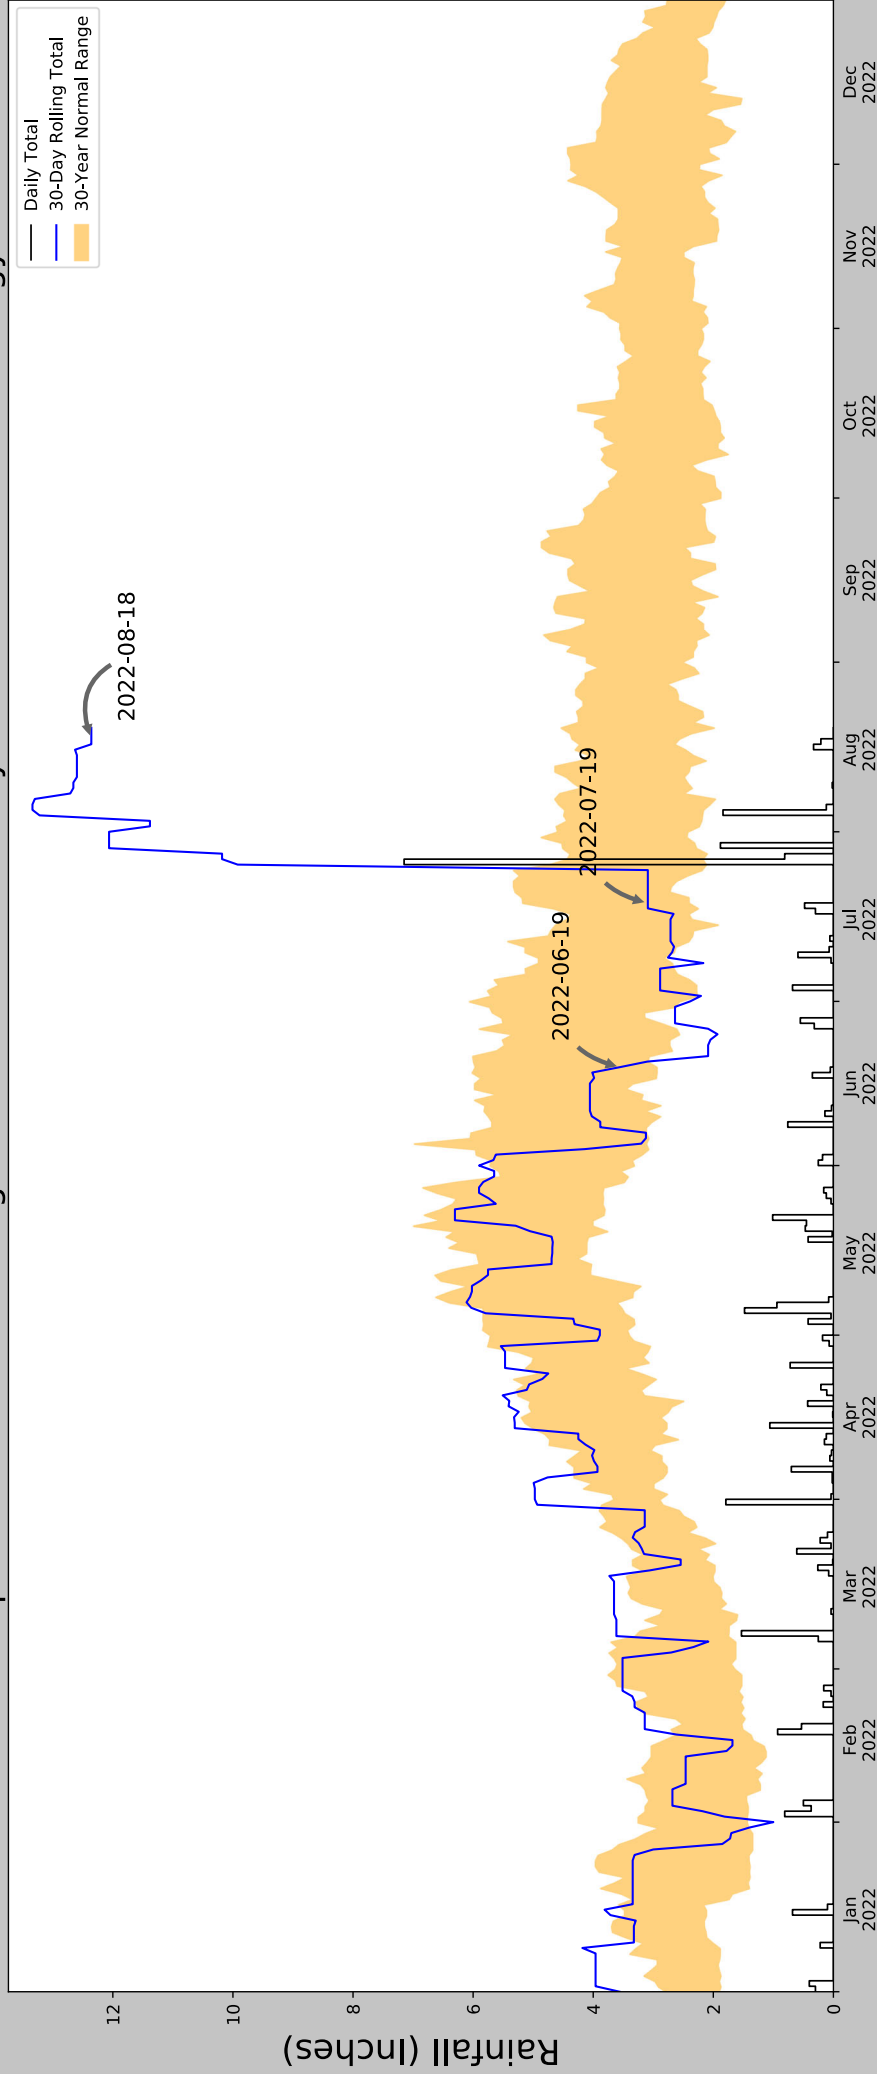
Coordinates	38.737681, -90.502689
Observation Date	2022-08-18
Elevation (ft)	440.34
Drought Index (PDSI)	Mild wetness (2022-07)
WebWIMP H ₂ O Balance	Dry Season

30 Days Ending	30 th %ile (in)	70 th %ile (in)	Observed (in)	Wetness Condition	Condition Value	Month Weight	Product
2022-08-18	2.570473	4.351575	12.358268	Wet	3	3	9
2022-07-19	2.414173	5.167323	3.090551	Normal	2	2	4
2022-06-19	2.944488	5.955906	3.547244	Normal	2	1	2
Result							Wetter than Normal - 15

An analysis of the Antecedent Precipitation Tool (APT) indicated wetter than normal conditions at the time of the field survey and is included in Appendix C.

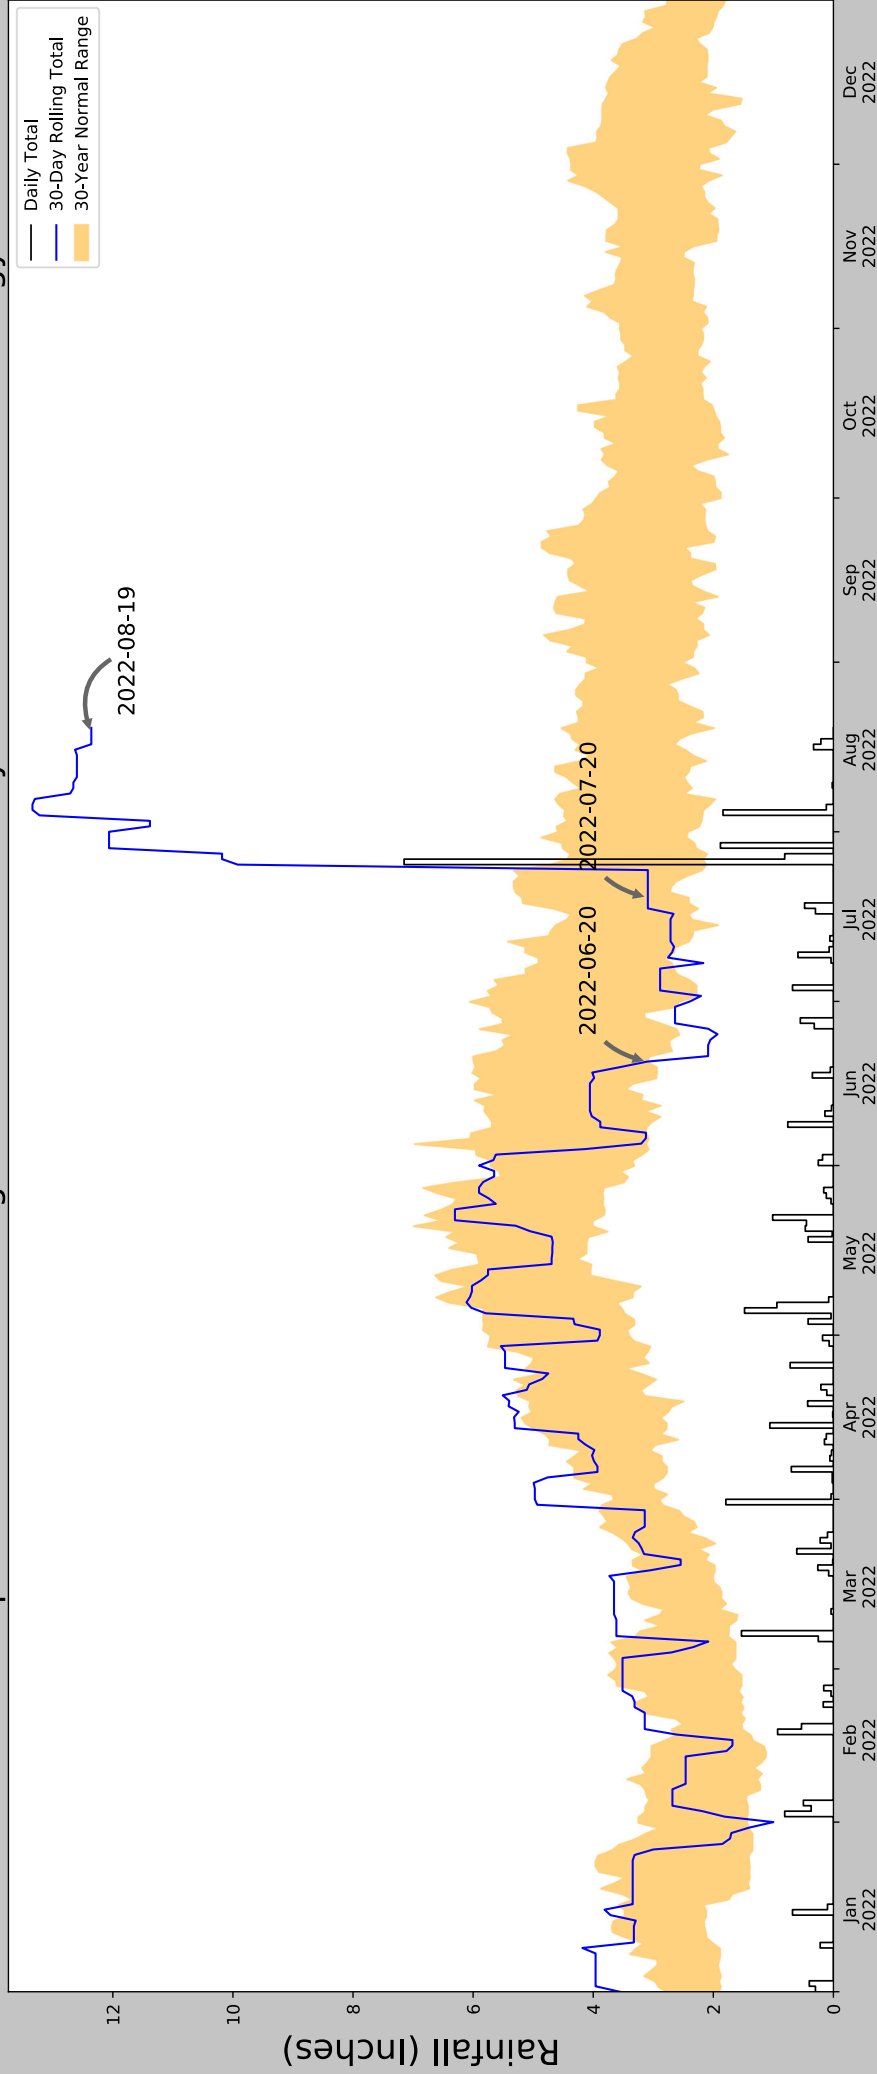
Coordinates	38.737681, -90.502689
Observation Date	2022-08-19
Elevation (ft)	440.34
Drought Index (PDSI)	Mild wetness (2022-07)
WebWIMP H ₂ O Balance	Dry Season

30 Days Ending	30 th %ile (in)	70 th %ile (in)	Observed (in)	Wetness Condition	Condition Value	Month Weight	Product
2022-08-19	2.373622	4.379528	12.358268	Wet	3	3	9
2022-07-20	2.414173	5.180315	3.090551	Normal	2	2	4
2022-06-20	3.096063	5.985433	3.098425	Normal	2	1	2
Result							Wetter than Normal - 15
